Case Study: The Historic Colorado State Capitol Building

Project Details:

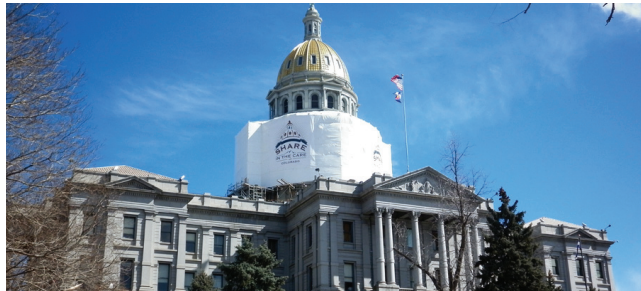
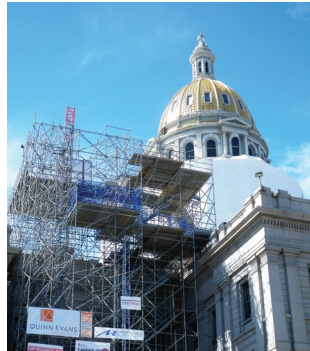
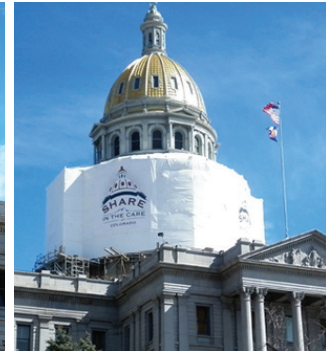
Due to the fragility and age of the roof, there was limited capacity available to support the dead weight of the scaffold alone, not to mention the equipment, materials and workers who would be utilizing it. DHG engineers developed a design to carefully distribute the scaffold loads amongst the designated bearing points across the rooftop to optimally apportion the dead load and maximize the allowable construction live loads. In order to achieve this, DHG engineers devised a method of setting stringers and sub-stringers at various angles and directions across the roof to properly transfer the loads to the building.

With minimal building façade penetration and limited access allowed, DHG engineers developed horizontal bearing (bumps) and tie connections that would not only ensure structural stability of the scaffold, but would respect the historical design and significance of the structure by not infiltrating the building façade. The number and spacing of the ties was complicated further with

the fact that the entire scaffold structure was to be enclosed with protective tenting to shield the exposed structure from weather during construction. The finalized enclosed scaffold was designed by DHG's engineers to resist winds up to 90 miles per hour. This design was put to the test in March of 2012 when Denver recorded gusts of 70 miles per hour during a spring storm.
